Instructions for identifying the affected UNILIFT AP50B

Instructions for identifying the affected MULTILIFT MSS

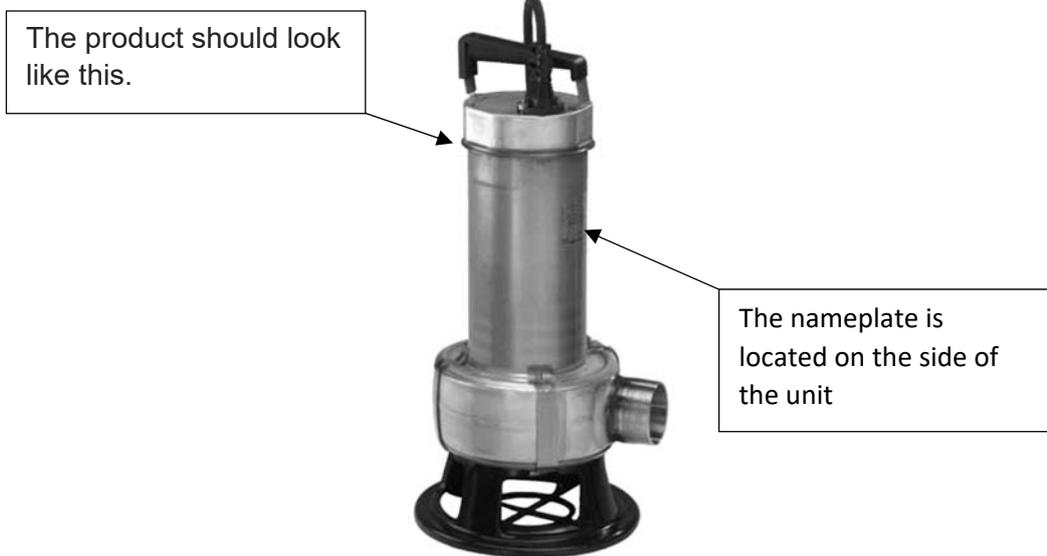
1. Verify that the pump looks like the one on the image:

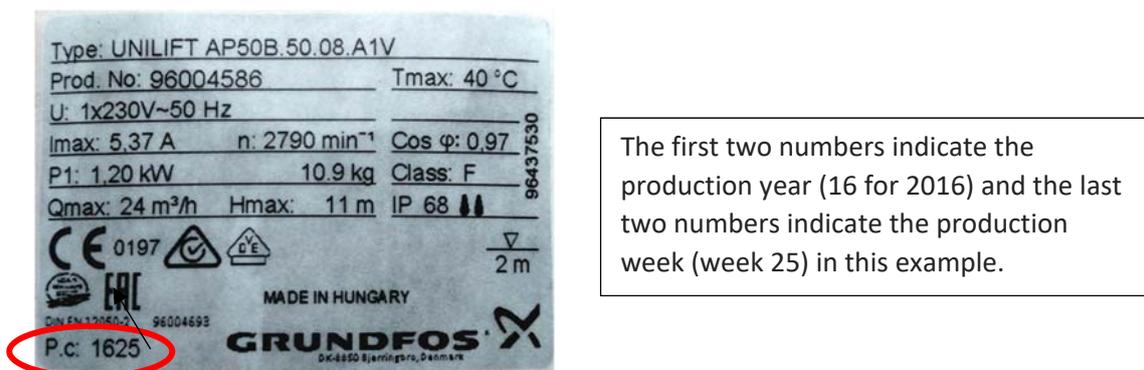
2. Check the nameplate:

3. The product needs to be replaced if the date indicates 1649 to 1735 (from week 49 in 2016 to week 35 in 2017).

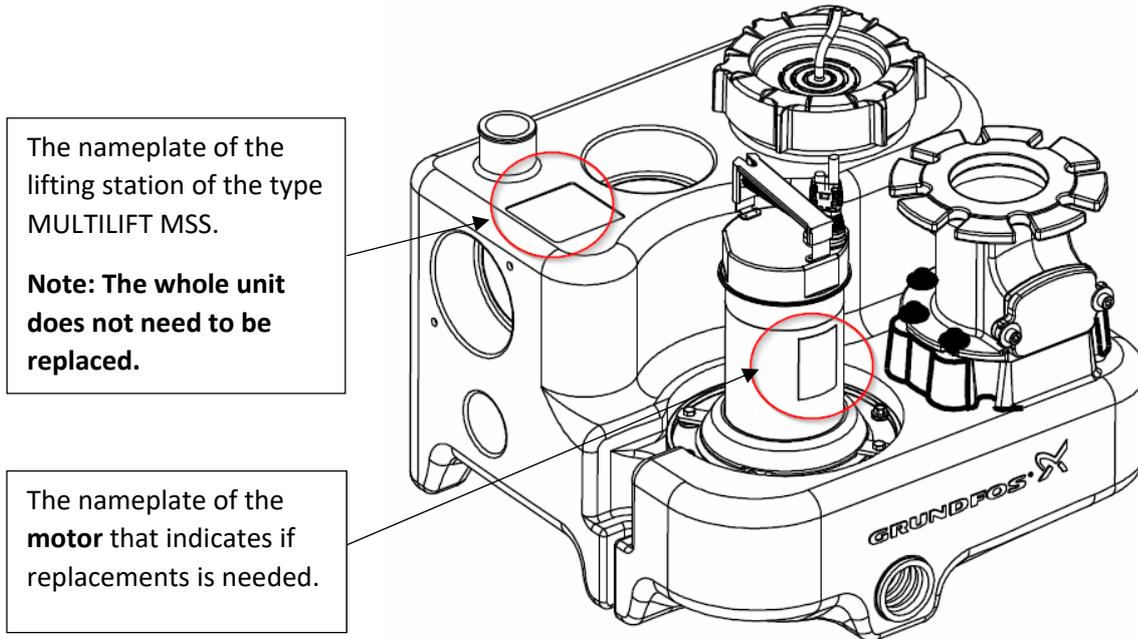
1. Verify that MULTILIFT MSS looks like the one on the image:

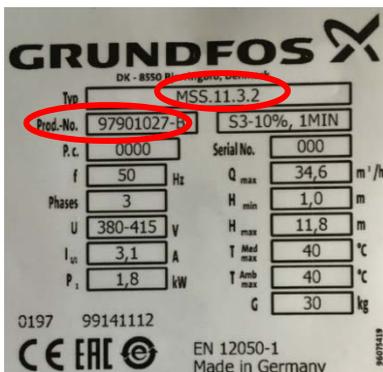
2. Check the nameplate of the **lifting station unit**:
 Check the nameplate of the MULTILIFT. MSS.11.3.2 indicates potentially affected product series.
 Check if the product number matches the listed numbers.

Product No:

97901027
97901029
98714824 (only China)
97901061
97901063
98721203

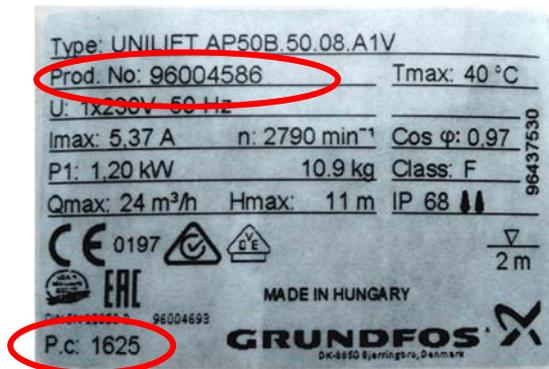
Check the nameplate of **the motor**:

Look for the product number and production codes (circled in red)..

The circled code in the bottom of the nameplate indicates the time of production (year/week). 16 for 2016, 25 for week 25.

Product No. of the motors that need to be replaced:

97823655

98094196

98167954

98167955

The motor must be replaced if the code is between 1227 to 1735 (from week 27 in 2012 to week 35 in 2017).
