# How advanced CRN pumps brought a reliable water supply to thousands of people

Aging pumps and pipework, operational problems, complicated maintenance, and major water leakages. These were a few of the reasons why the Carbonero el Mayor City Council decided to take action and implement new technology to improve the performance of both the hydraulics and motor of one of its water installations. Grundfos CRN pumps helped to optimise the system and maintain a reliable, efficient operation for years to come.

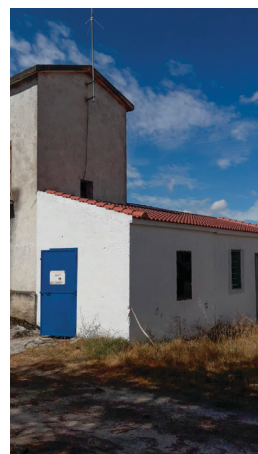
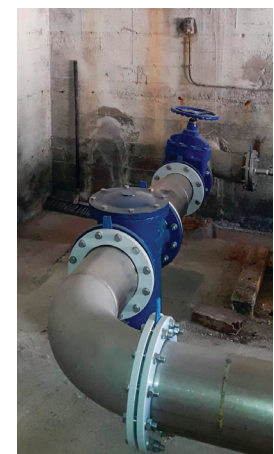
*A detailed view of the new pipes inside the pumping station at the plant.*

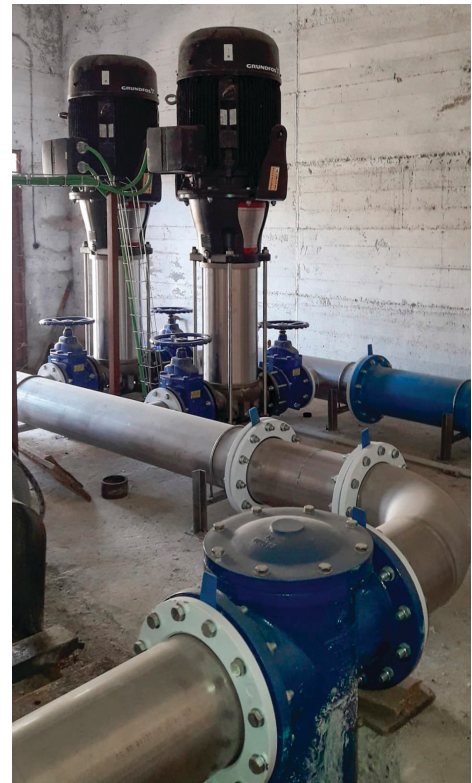
Two Grundfos CRN pumps provide a reliable water supply to thousands of people.
