# MOST PEOPLE UNDERSTAND THAT COOLING TOWERS ARE ESSENTIAL TO INDUSTRIES AND COMMERCIAL BUILDINGS. YET, THEY ONLY THINK ABOUT THEM WHEN A BREAKDOWN OCCURS THAT IMPACTS A PRODUCTION PROCESS OR THE INDOOR TEMPERATURE ON A HOT SUMMER'S DAY.

The following is a case story of a Grundfos customer that has identified Grundfos iSOLUTIONS as the right choice for solving its challenges related to water treatment in cooling towers. The solution is currently in the planning phase.

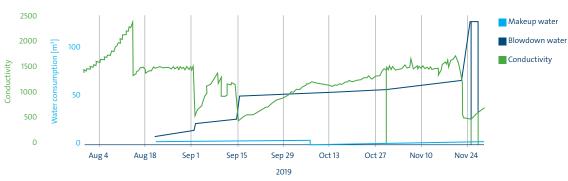
Inefficient manual Blowdown control on site

As shown in the above chart, conductivity and water balance were unstable, affecting the performance of the system and increasing freshwater consumption. A make-up water valve was opened manually by accident, but not closed again. This led to one of the sump tanks constantly overflowing without monitoring, warnings or alarms for several days until the next routine check.
