DECENTRALISED WATER TREATMENT:

# SAFE, EFFECTIVE WATER CONDITIONING IN COOLING TOWERS

**GRUNDFOS  
iSOLUTIONS** | A SMART SOLUTION  
FOR YOU

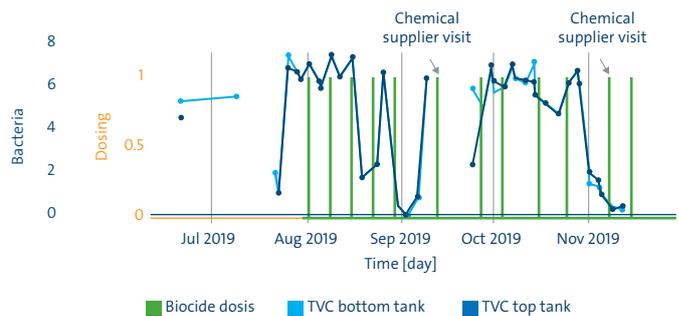
The hoses for the addition of biocide were either empty or full of air, causing faulty dosing. As a consequence, the bacteria count was double the recommendation of the chemical supplier, who visited the site ten times per year and was missing bacteria fluctuation peaks between visits.

Correlation between ineffective biocide dosing and cell count

As shown in the above chart, conductivity and water balance were unstable, affecting the performance of the system and increasing freshwater consumption. A make-up water valve was opened manually by accident, but not closed again. This led to one of the sump tanks constantly overflowing without monitoring, warnings or alarms for several days until the next routine check.

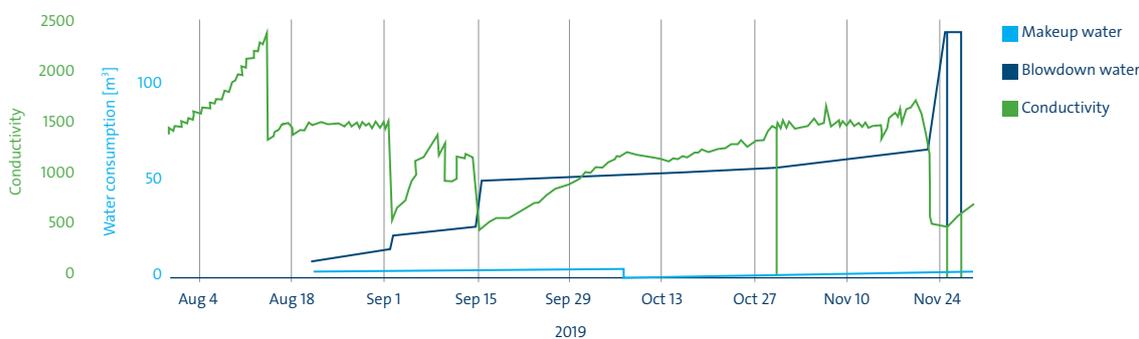
*Inefficient manual Blowdown control on site*
