The following is a case story of a Grundfos customer that has identified Grundfos iSOLUTIONS as the right choice for solving its challenges related to water treatment in cooling towers. The solution is currently in the planning phase.

Cooling tower issues affect water efficiency and safety

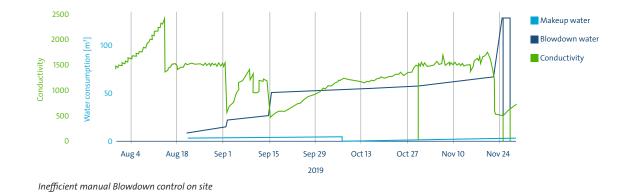
Correlation between ineffective biocide dosing and cell count

As shown in the above chart, conductivity and water balance were unstable, affecting the performance of the system and increasing freshwater consumption. A make-up water valve was opened manually by accident, but not closed again. This led to one of the sump tanks constantly overflowing without monitoring, warnings or alarms for several days until the next routine check. At another point during this period, one of the main supervising PLC's firmware was upgraded. After that, the make-up water was activated constantly by mistake for three consecutive days. Again, a waste of water. The company has a strong commitment to reducing its water footprint, so this was simply unacceptable.
